2023 Lakes Monitoring Annual Report

Lake Bradford

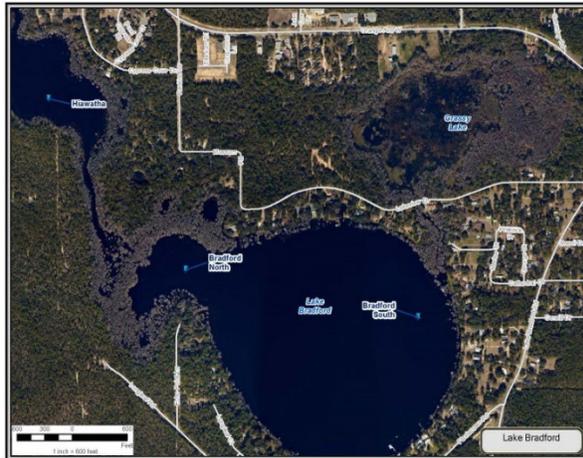
Figure 1. Water Quality Monitoring Locations

Lake Bradford maintains a consistent permanent pool of water, which is conducive to water quality and biological monitoring activities. As such, annual water quality data is available for Lake Bradford dating back to 1993 and biological monitoring has occurred since 2001. The following tables and charts provide water quality (annual geometric means) and biological results covering the time period of 2011-2022. **Figures 1 & 2** display the water quality and biological LVI monitoring locations within Lake Bradford.

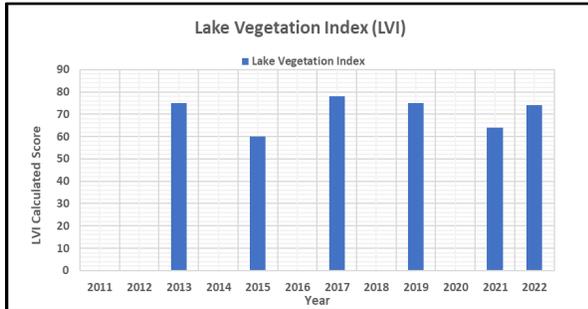
Chart 7. Lake Bradford Yearly LVI Score

Lake Bradford’s vegetation community has a narrow diversity structure with native plant species. The overall LVI calculated score was “74” which indicates it’s a “Healthy” plant community and has improved slightly from last year in plant species biological quality. The shoreline “Torpedo Grass” was the only exotic invasive recorded this survey season. The extensive housing development around 80% of the lake leaves little room for littoral zone growth and the dark colored water shades a submerged plant community from thriving. The scores vary from year to year based on the surveyed sections, which are determined by a random number sequence. The littoral shoreline is dominated with the Bald Cypress tree (*Taxodium* sp.) with a few “Sweetbay” Magnolia (*Magnolia virginiana*), and “Red” Maples (*Acer rubrum*) mixed in.
