LAKE ECOSUMMARY

Lake Bradford

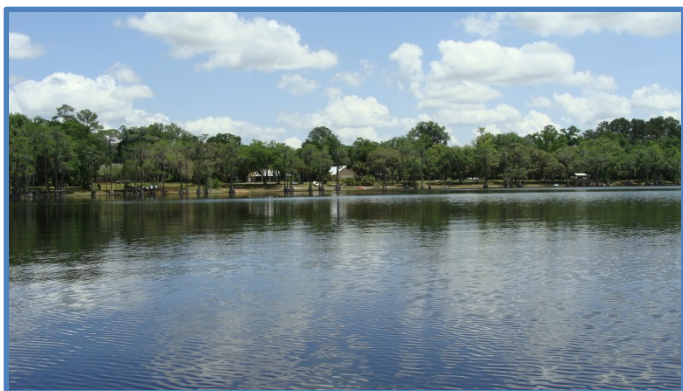
For the LVI, species lists were developed for four of twelve sections of the lake (Figure 1), and the following information was derived from those lists: percent native species, percent invasive exotic species, percent sensitive species, and the coefficient of conservatism (C of C; a measure of how tolerant a species is to disturbance) of the dominant species. According to DEP SOP LT 7000, the LVI score ranges and categories are: (78-100) Exceptional; (43-77) Healthy; and (0-42) Impaired. DEP’s revised impairment threshold score of 43 and higher fully meet the expectation of a healthy, well balanced community, and scores below 42 are considered impaired. The LVI was sampled per DEP SOP FS7310 and calculated per DEP SOP LT7000.

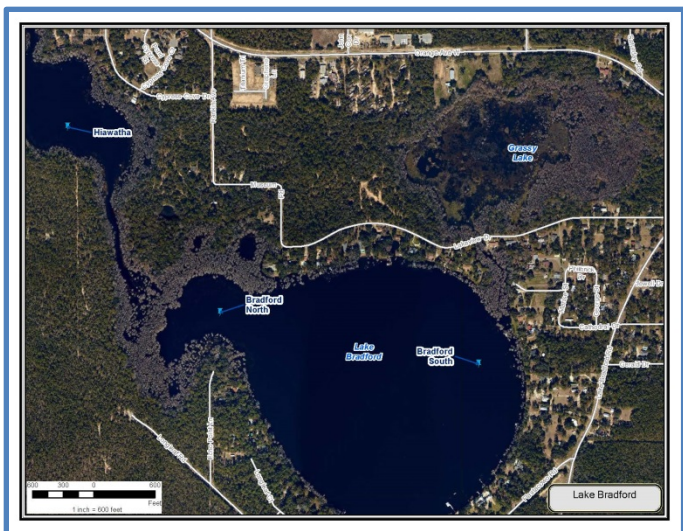
Figure 2. Map of Lake Bradford. Sampling sites are marked “North” and “South” on the map below. Water quality samples are collected from each site along with water parameters such as Dissolved Oxygen, Conductivity, pH level, Temperature, Secchi Disk reading and depth.
