2025 Lakes Monitoring Annual Report

Lake Cascade

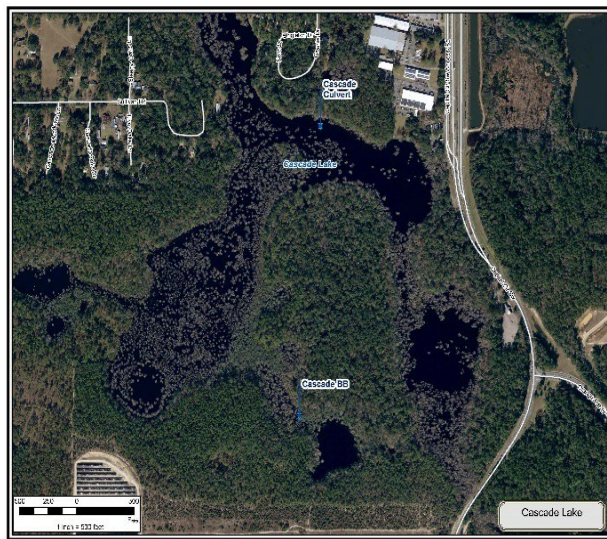
Figure 1. Water Quality Monitoring Locations

Lake Cascade maintains a highly variable permanent pool of water, which can be inconducive to water quality and biological monitoring activities. For the years 2011, 2012, 2019 and beginning of 2023 the lake was in a dry condition absent of necessary water to complete monitoring activities. Generally flowing from west to east, Lake Cascade is the western most lake in the Bradford Chain of Lakes residing immediately upstream of Lake Hiawatha and adjacent to the Apalachicola National Forest from which Cascade is dependent on water inflow. Annual water quality data is available for Lake Cascade dating back to 1991 and biological monitoring has occurred since 2001. The following tables and charts provide water quality (annual geometric means) and biological results covering the period of 2011-2024. **Figures 1 & 2** display the water quality and biological monitoring locations within Lake Cascade.

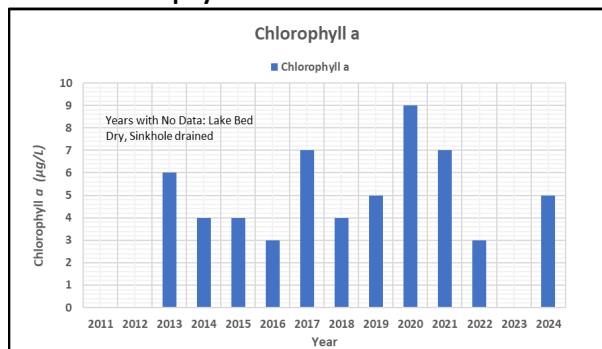
Chart 3. Chlorophyll

extremely low levels once again, prohibiting sample collection for April 2024. Summer rains refilled Cascade again for samples to be collected for the rest of the 2024 year. Last year data shows that there was a slight increase in all three key nutrient indicators for lake health: chlorophyll, total nitrogen, and total phosphorus. This is due to the high organic material that accumulated during the drought-induced, exposed lake bottom. However, through 2024, there are no significant trends indicated for any of the three parameters mentioned.

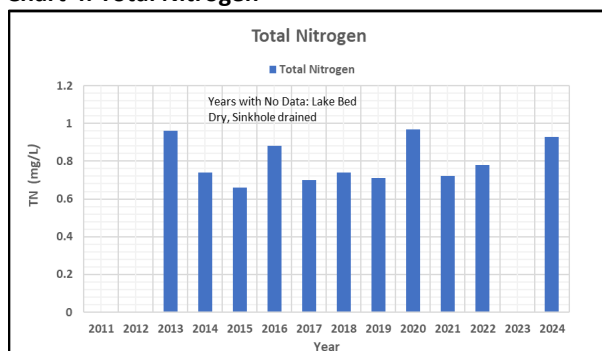
Chart 4. Total Nitrogen

Dark, tannic, colored water prevents sunlight penetration thru the water column, thus limiting algal production. The elevated Total Nitrogen values noted in **Table 2** are natural, due to the decomposition of organic matter such as leaves and vegetation. The resulting high organic nitrogen values is the driving factor of the Total Nitrogen concentrations.

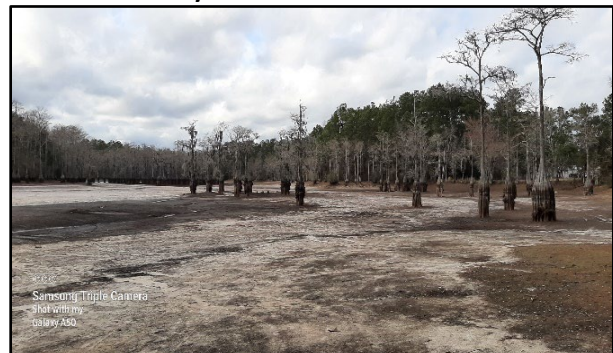
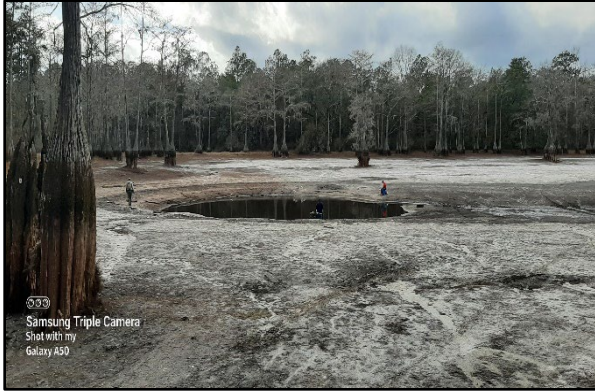
The data within the above charts and tables is used to determine overall lake health and to assess whether any data trends are evident. Lake Cascade was dry at the end of year 2022 thru the first half of 2023. Water levels never sufficiently recovered and as such no monitoring activities occurred during the entire 2023 year. The lake received enough rain to fill the lake for the first quarter of 2024 but then receded to

Below: Photos 1 & 2. Lake Cascade in a dry condition January 2023.

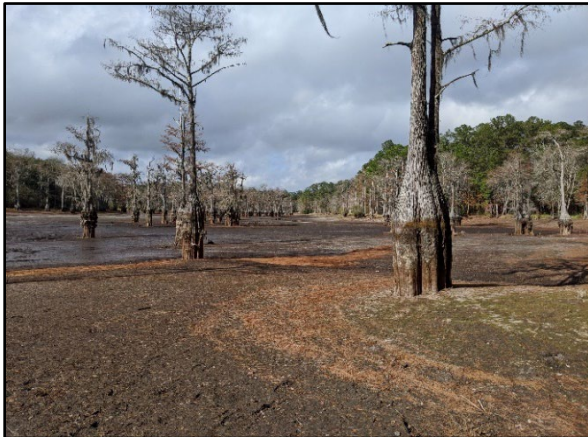
Photo 3. High watermarks on a Pond Cypress tree, illustrating the extreme water fluctuations within Lake Cascade.

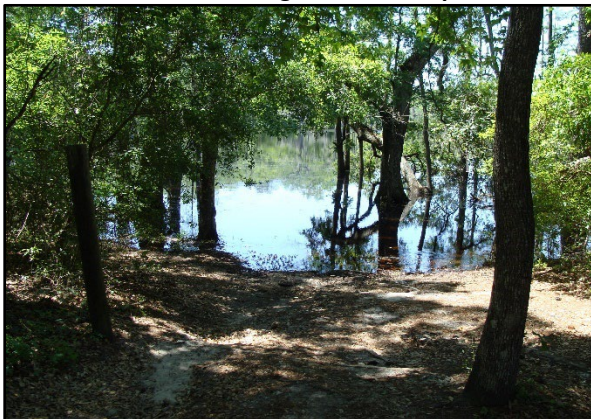
Photo 4. Water levels begin to return April 2024.
