LAKE ECOSUMMARY

Lake Hiawatha

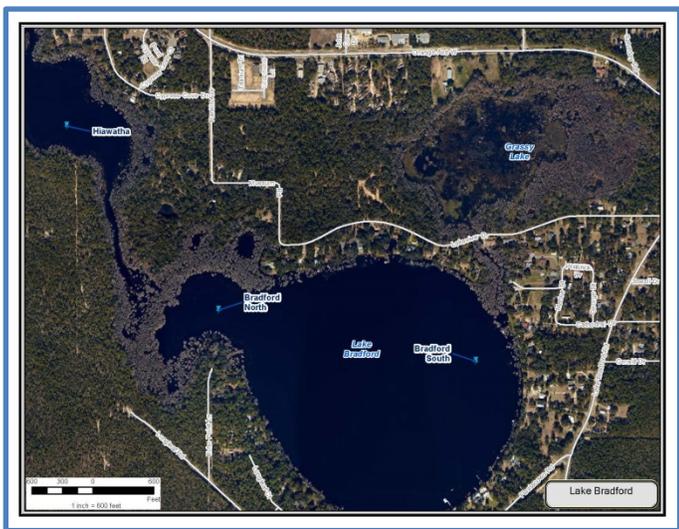
Figure 2. The lake map of Lake Hiawatha. The sampling site is located at the upper corner of the map. Water quality samples are collected from this site along with water parameters such as Dissolved Oxygen, Conductivity, pH level, Temperature, Secchi Disk reading and depth.

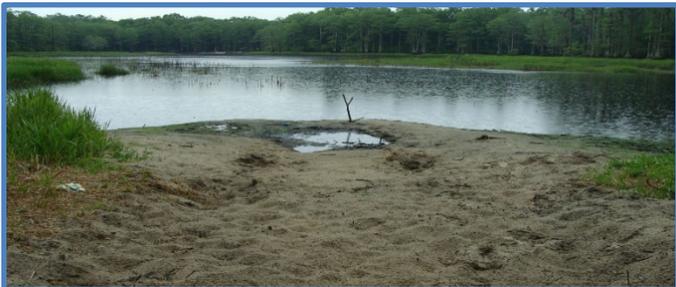
The 2 photos below show the low water levels during the Summer of 2020, which precluded both water quality and biological sampling efforts.

Hiawatha boat launch with sandy conditions.
