# 2025 Lakes Monitoring Annual Report

## Lake Kanturk

*Lake Kanturk is within the northside subdivision of Killearn Estates, located just north of Interstate-10 near Thomasville Road within the City of Tallahassee corporate limits. Lake Kanturk resides downstream of Lakes Kinsale and Killarney.*

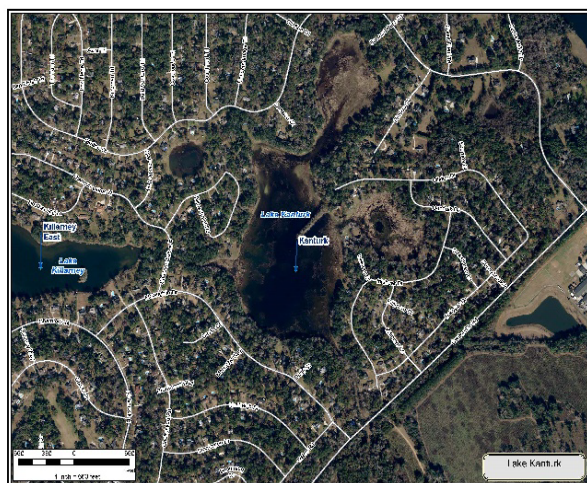
**Figure 1. Water Quality Monitoring Locations**

Lake Kanturk does not maintain a consistent permanent pool of water, which is inconducive to water quality and biological monitoring activities. However, water quality data is available for Lake Kanturk dating back to 1998 and biological monitoring has occurred since 2001. During 2023, no water quality samples were collected due to low water levels and an exposed lakebed. Surprisingly, 2024 brought increased water levels appropriate to collect all 4 quarters of sampling. The following tables and charts provide water quality (annual geometric means) and biological results covering the time-period of 2011-2024. **Figures 1 & 2** display the water quality and biological monitoring locations within Lake Kanturk.

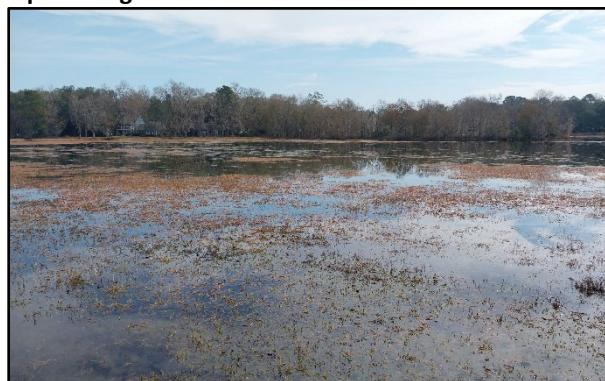
**Photo 1. Typical appearance for Lake Kanturk during year 2024. Heavy mixture of upland and aquatic vegetation.**

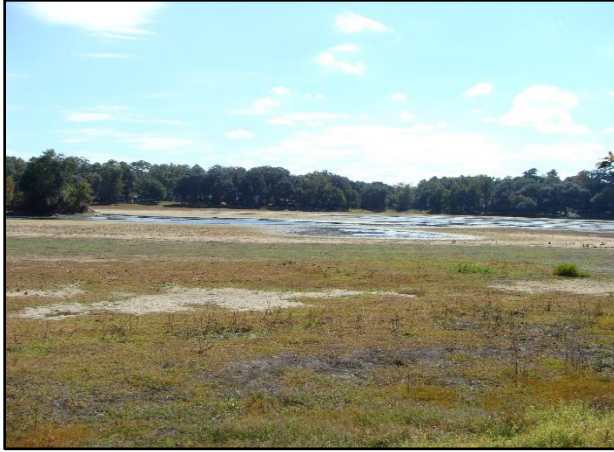
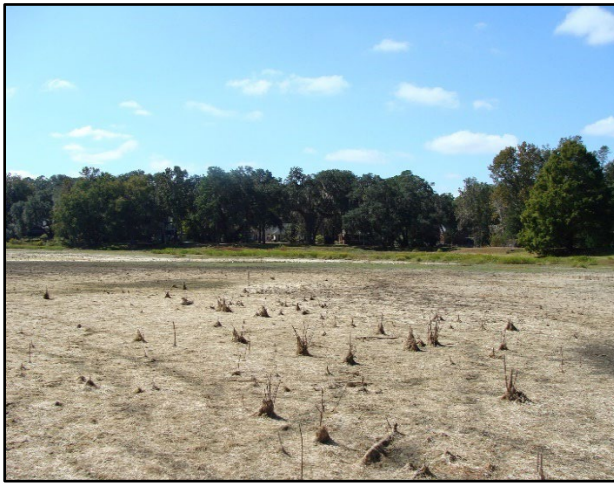
Suburban housing developments surround Lake Kanturk and the contributing drainage basin. Previous research shows that local area best management practices (BMP’s) are the most effective method of controlling nutrient inputs to the lake and supply necessary drainage volume to hydrate the lake. However, even under normal rainfall patterns, the lake is unable to maintain its permanent pool volume. The cyclical pattern of the lake going dry, establishing terrestrial plants and the subsequent reflooding of the lake bottom, is the primary catalyst for nutrient exceedances for this lake.

Photos 2 & 3. Below photos (October 2022) show extremely low water levels and terrestrial grasses thriving on Kanturk's lakebed.

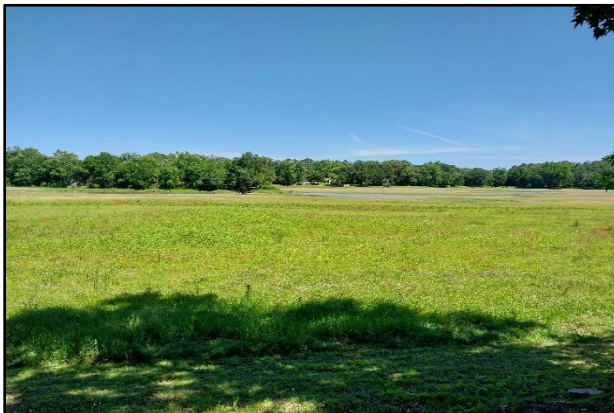
Photo 4. Below photo taken May 2023. Same location as above, but grass overtaking lake bottom.

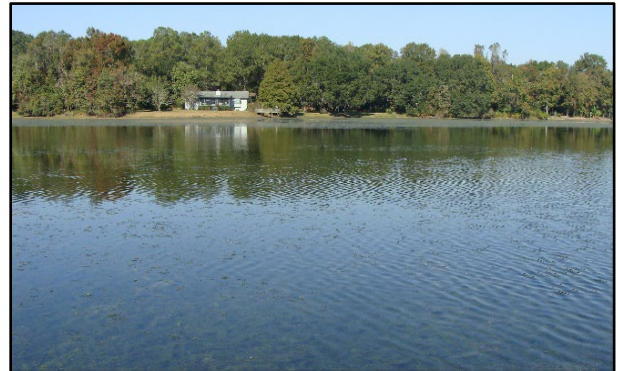
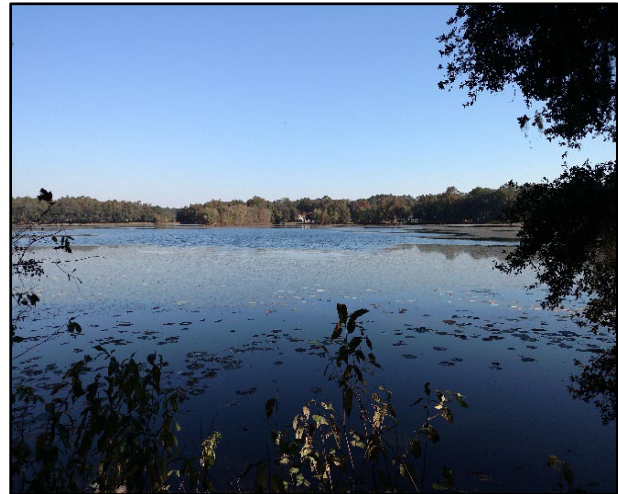
Lake Kanturk’s vegetative community is rich with native and exotic nuisance plant species. Due to low water levels for the past several years, an LVI plant survey has not been completed. **Chart 6** illustrates typical plant species that are found within Lake Kanturk. Unfortunately, *Hydrilla verticillata* has infested Lake Kanturk via the connection with Lake Killarney. This invasive plant effectively prohibits the establishment of native submerged vegetation. However, *Hydrilla* does support a healthy and vibrant Large-Mouth Bass population. Providing coverage for algal growth, aquatic invertebrates forage along the *Hydrilla* vegetation. This initiates the food web interaction that ultimately produces the popular bass fishing. The plants listed in “Red” (in **Chart 6**) indicate exotic nuisance vegetation that ideally should be targeted for removal.

Photos 5 & 6 Photos below show Lake Kanturk full of water, notice the thick *Hydrilla* just below the water's surface.
