2025 Lakes Monitoring Annual Report

Lake Killarney

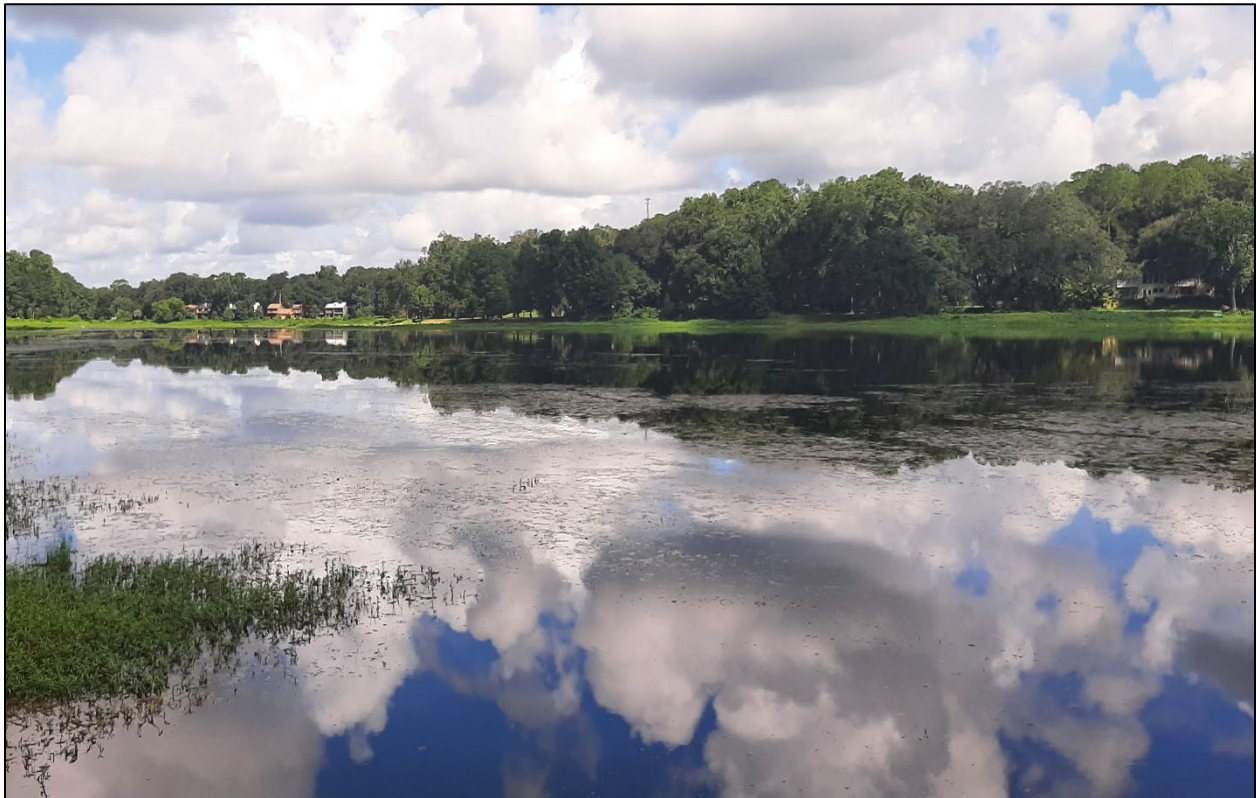
- Lake Killarney Physiographic Province: Red Hills
- Publicly Accessible: No (Private)
- Surface Area: 80 acres
- Drainage Basin: 5,642 acres
- Maximum Depth: 8 feet
- Average Depth: 4 feet
- [Trophic Classification](#): Eutrophic
- [Fish Consumption Advisories](#): None
- Lake Type: Clear-Acidic
- Water Quality Conditions: Marginal
- Water Quality Impairments: 4e Restoration Plan (Chlorophyll, Total Nitrogen, & Total Phosphorus)
- Biological Health: Poor

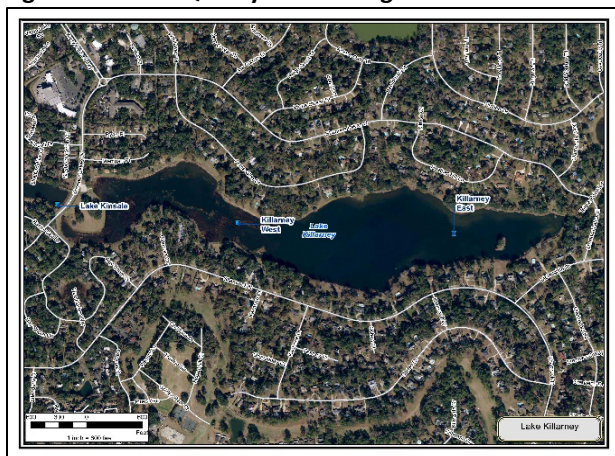
Figure 1. Water Quality Monitoring Locations

Lake Killarney does not maintain a consistent permanent pool of water, which is inconducive to water quality and biological monitoring activities. However, water quality data is available for Lake Killarney dating back to 1990 and biological monitoring has occurred since 2001. The following tables and charts provide water quality (annual geometric means) and biological results covering the time-period of 2011-2024. **Figures 1 & 2** display the water quality and biological monitoring locations within Lake Killarney.

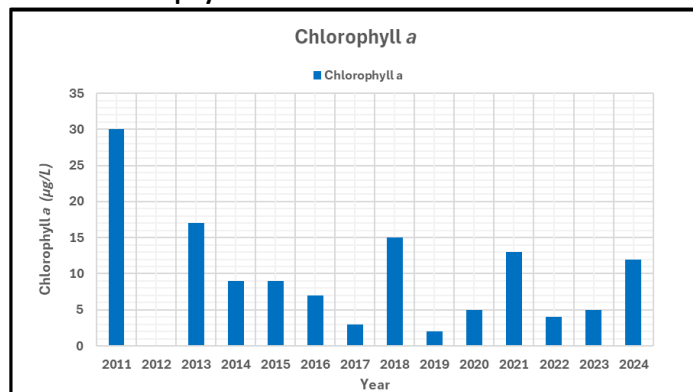
Chart 3. Chlorophyll

The Chlorophyll-*a* data geomean for 2024 increased to 12 µg/L compared to the previous two years of

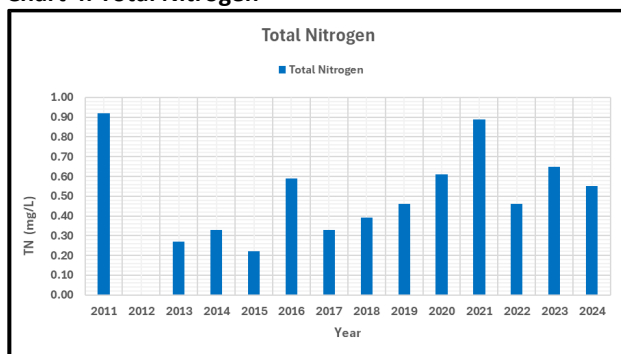
Chart 4. Total Nitrogen

2022 (4 µg/L) and 2023 (5 µg/L). Total nitrogen and total phosphorus geomeans are 0.55 mg/L and 0.39 mg/L respectively. Urban housing developments surround Lake Killarney and the contributing drainage basin. Previous research shows that in place best management practices (BMP's) are effective at controlling nutrient inputs to the lake system and supplying necessary drainage volume to hydrate the lake. However, even under normal rainfall patterns the lake is unable to maintain its permanent pool volume. The cyclical pattern of the lake going dry, establishing terrestrial plants and the subsequent reflooding of the lake bottom, is the catalyst for nutrient exceedances for this lake.

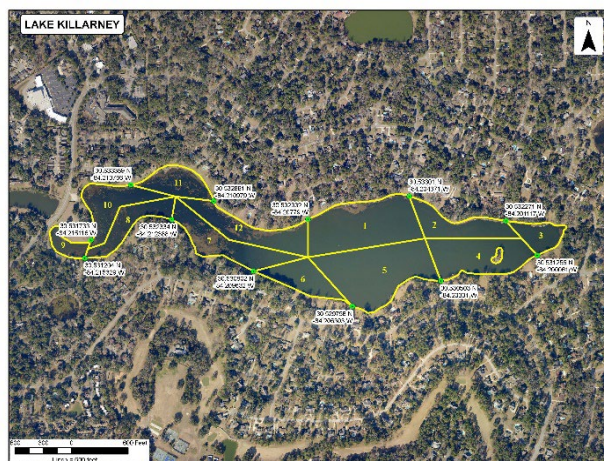
Figure 2. Biological Monitoring LVI Quadrants

The lake is divided into twelve sections (**Figure 2**) with four of these sections chosen at random to be evaluated. The evaluation occurs during the summer months of the year when vegetation is actively growing. Criteria documented are percent native species, percent invasive exotic species, percent sensitive species, and the coefficient of conservatism (C of C; a measure of how tolerant a species is to disturbance) of the dominant species. According to DEP SOP LT 7000, the LVI score ranges and categories are: (78-100) Exceptional; (43-77) Healthy; and (0-42) Impaired. DEP’s revised impairment threshold score of 43 and higher fully meet the expectation of a healthy, well-balanced community, and scores below 42 are considered impaired. The LVI was sampled per DEP SOP FS7310 and calculated per DEP SOP LT7000.

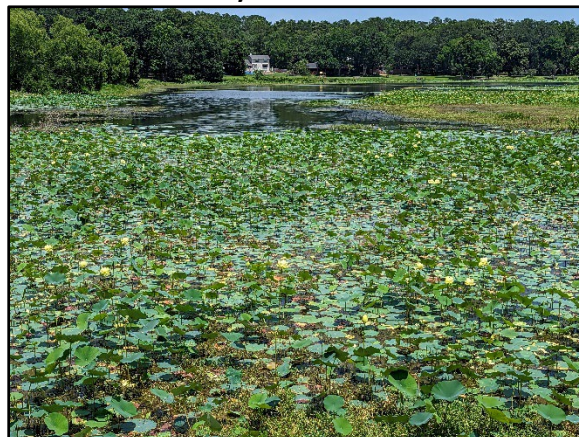
Photo 1. Native flowering Lotus re-establishing itself in Lake Killarney.

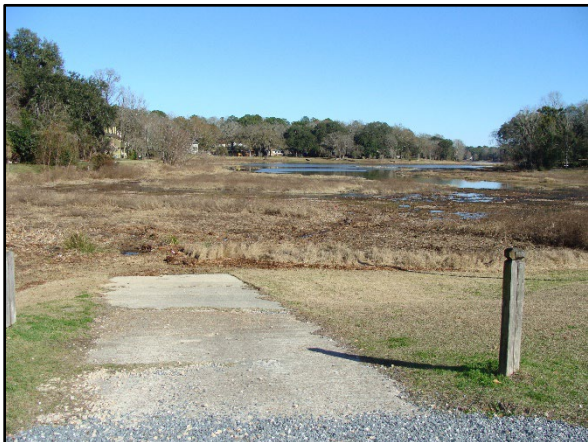
Photo 2. Example of how Lake Killarney when rainfall is sparse for an extended period.

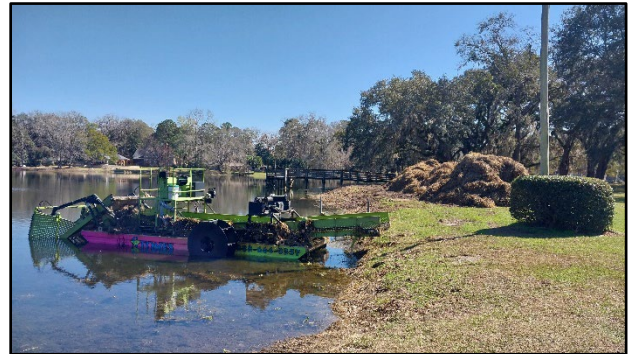
Photo 3. Mechanical harvester unloading aquatic vegetation that has been removed from Lake Killarney. (December 2024)

December 2024, the Killlearn Homeowner Association (KHA) funded an extensive aquatic plant removal project by contracting a mechanical harvester. This is a giant step in the right direction to control the overgrowth of aquatic plants. The removal continued through February of 2025. Mechanical harvesting is the preferred method for large-scale vegetative removal, as it selectively targets species and removes the biomass from the lake. Moving forward (upon completion harvesting), it's anticipated an herbicidal treatment program will be used to target undesirable aquatic vegetation.

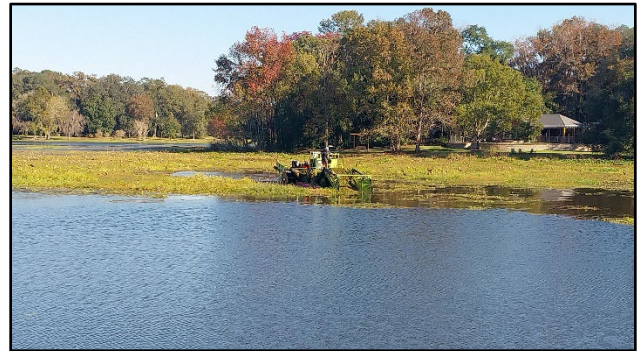
Photo 4. Mechanical harvester removing vegetation along the lake's surface. (December 2024)

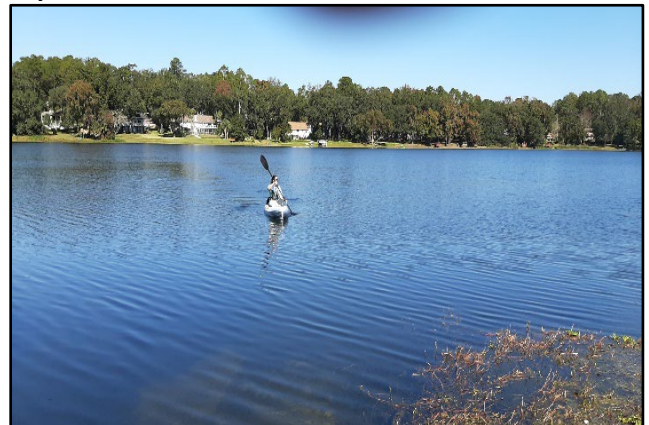
Photo 5. "East" sampling site where a kayak is the appropriate vessel to collect water samples on this day.
