# 2023 Lakes Monitoring Annual Report

## Lake Kinsale

*Lake Kinsale is located within the Killearn Estates Subdivision off Shannon Lakes Road just West of Lake Killarney, and within the City of Tallahassee corporate limits. Lake Kinsale is a private community lake.*

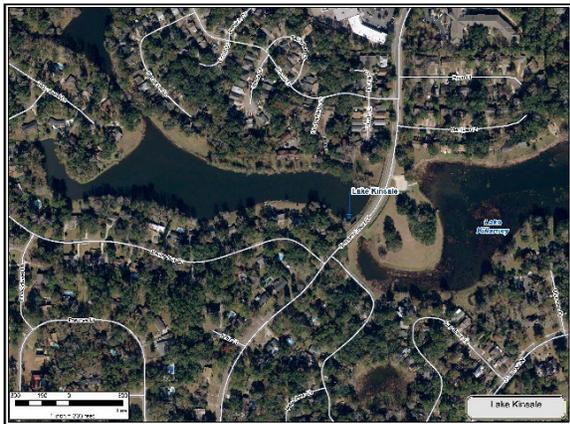
**Figure 1. Water Quality Monitoring Locations**

Lake Kinsale maintains a relatively consistent permanent pool of water, making it conducive to perform water quality monitoring activities. Water quality data collection began in 2017 with an effort to collect additional data to better understand the function of the Killlearn Chain of Lakes (KCOL). The following tables and charts provide water quality (annual geometric means) results covering the time period of 2017-2022. **Figure 1** shows the water quality monitoring location within Lake Kinsale.

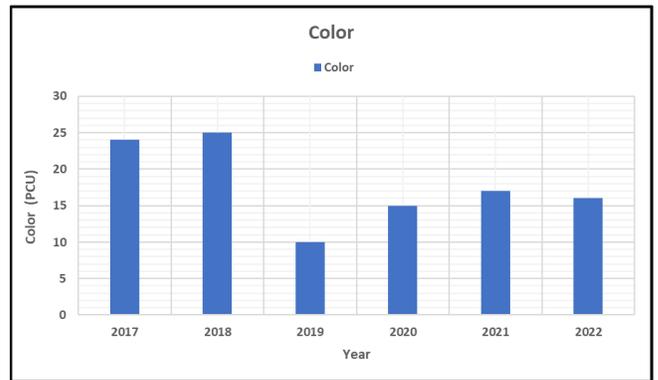
**Chart 1. Color**

The data within the above charts and the corresponding **Table 2**, are used to determine overall lake health and to assess whether there are data trends evident. The City’s Lakes Monitoring Program utilizes the Mann-Kendall Statistical Trend Analysis test to determine if there are statistically significant trends.

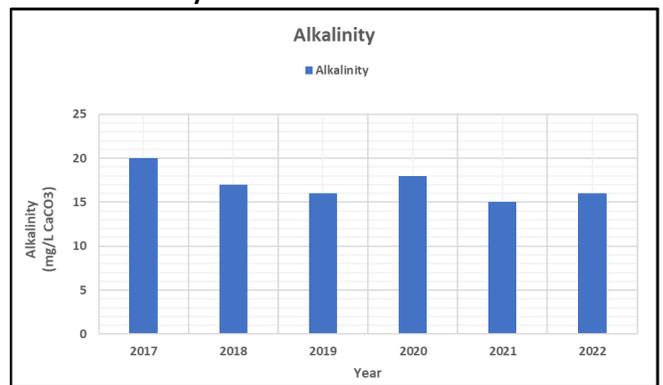
**Chart 2. Alkalinity**

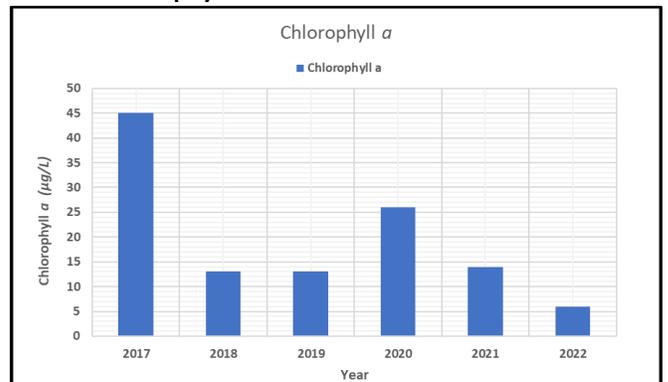
**Chart 3. Chlorophyll**

Water quality conditions are best characterized as marginal, while the biological community is poor. This characterization concurs with the FLDEP assessment of water quality. Impairments for Chlorophyll-*a*, Total Nitrogen and Total Phosphorus are assessed as a “clear acidic” lake. While water quality challenges certainly exist within Lake Kinsale, Chlorophyll-*a*

concentrations seem to be declining as well as the frequency with which algal blooms are occurring.

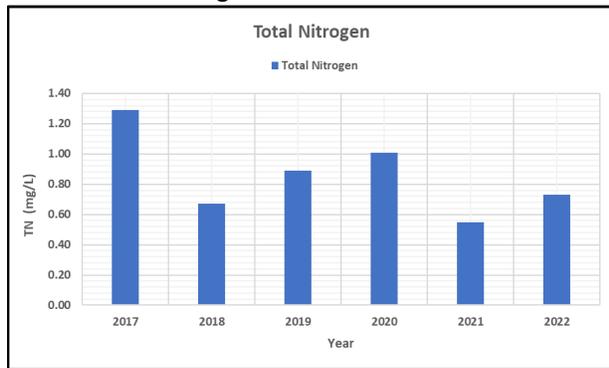
**Chart 4. Total Nitrogen**

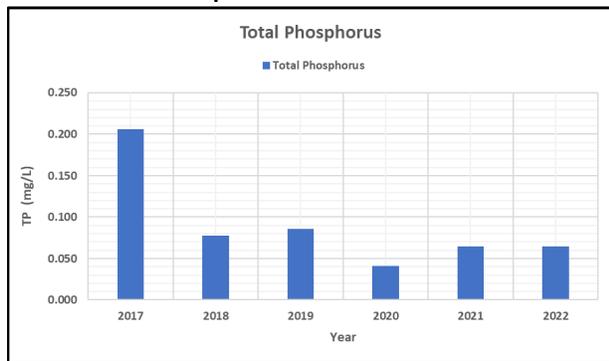
**Chart 5. Total Phosphorus**

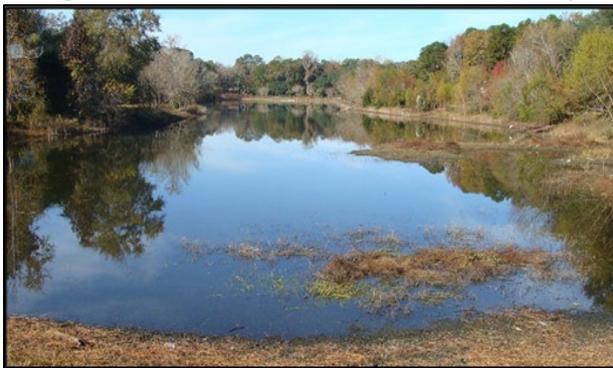
**Figure 2. Low water level during periods of below average rainfall.**

Lake Kinsale is the most upstream water body within the Killarney Chain of Lakes, (KCOL), discharging downstream to Lake Killarney. While Lake Kinsale maintains a relatively consistent permanent pool of water, it is a very shallow lake (average depth 3 feet) and thus more susceptible to desiccation during periods of drought or lower than average rainfall. When the lake bottom is dry, terrestrial grasses and plants overtake a large portion of the lake bottom. When ample rainfall occurs to refill the lake system, established terrestrial plants die and decompose. This vegetative decomposition releases stored nutrients and can lead to the production of algal blooms. These algal blooms create high Chlorophyll-*a* and total nitrogen concentrations. Additionally, the Red Hill clay soils within the KCOL drainage basin also contribute to elevated phosphorus levels due to the high phosphorus concentrations naturally found within this soil type.
